RP 732

## TRAILER REAR IMPACT GUARD REPAIR GUIDELINES

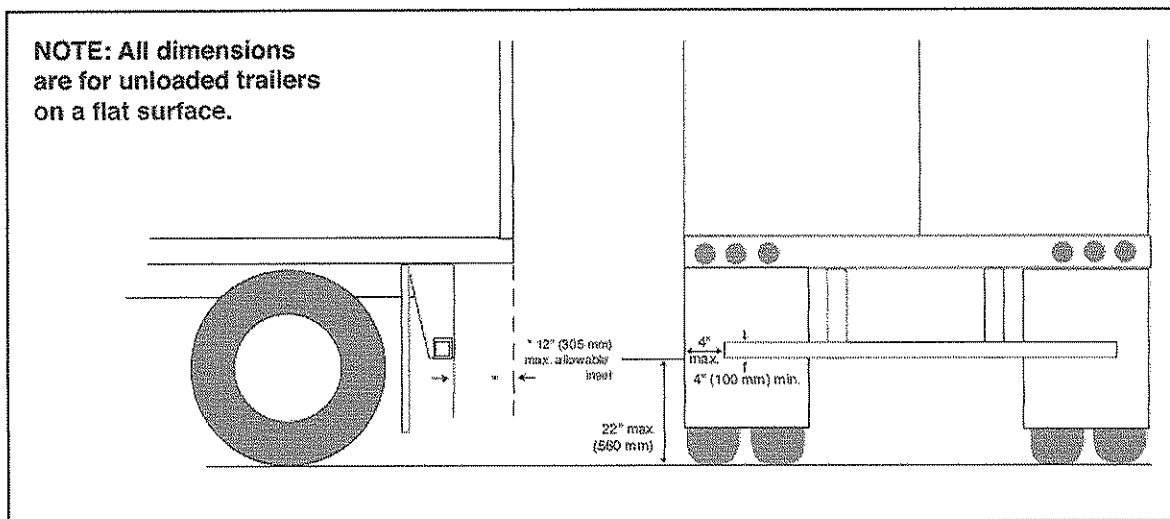
Figure 1

guards. The rules also require a certification plate or label to be located on the forward-facing surface of the horizontal member and located within 12 inches of the outside of the horizontal member on the curbside. This label must give the name and address of the guard manufacturer, month and year of manufacture and the letters "DOT." The guard must conform to the dimensions shown in **Figure 1**.

**NOTE: FMCSR 393.86, which became effective on October 1, 1999, requires that equipment users maintain the underride guard in a close-to-like new condition. This, in part, means that it should not deviate improperly from the dimensions given in Figure 1.**

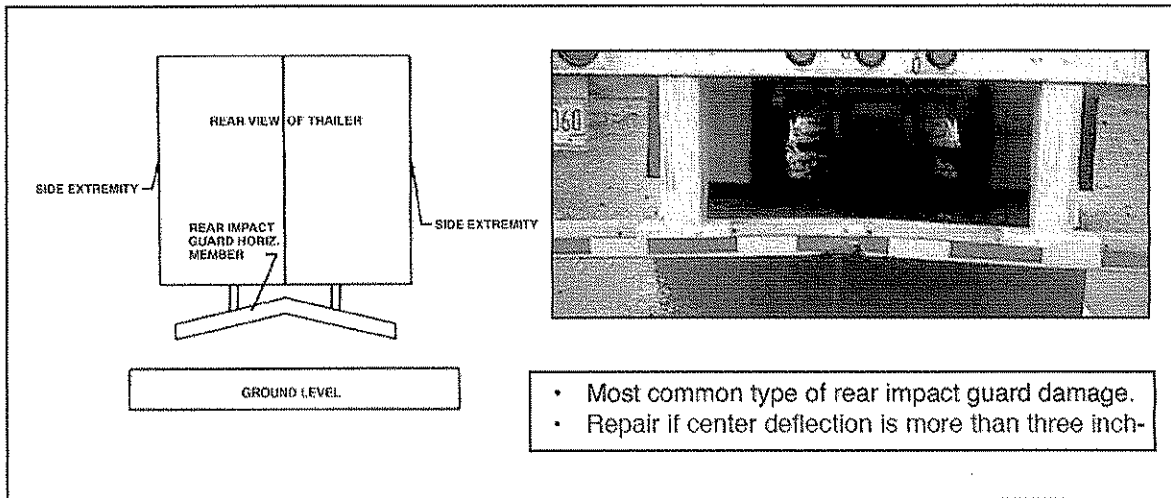
Figure 2

damage falls into a few distinct categories. A common type of damage is a vertical bend in the horizontal member of the impact guard, shown in Fig. 2. Manufacturer data and a study commissioned by the Technology & Maintenance Council with the National Research Council of Canada's Centre for Surface Transportation Technology indicates that this type of damage does not affect a particular guard's ability to meet the strength or energy absorption requirements of FMVSS 223 and 224 if the deflection is three inches or less. If the bend exceeds three inches, it should be repaired to conform to the dimensions shown in Figure 1.

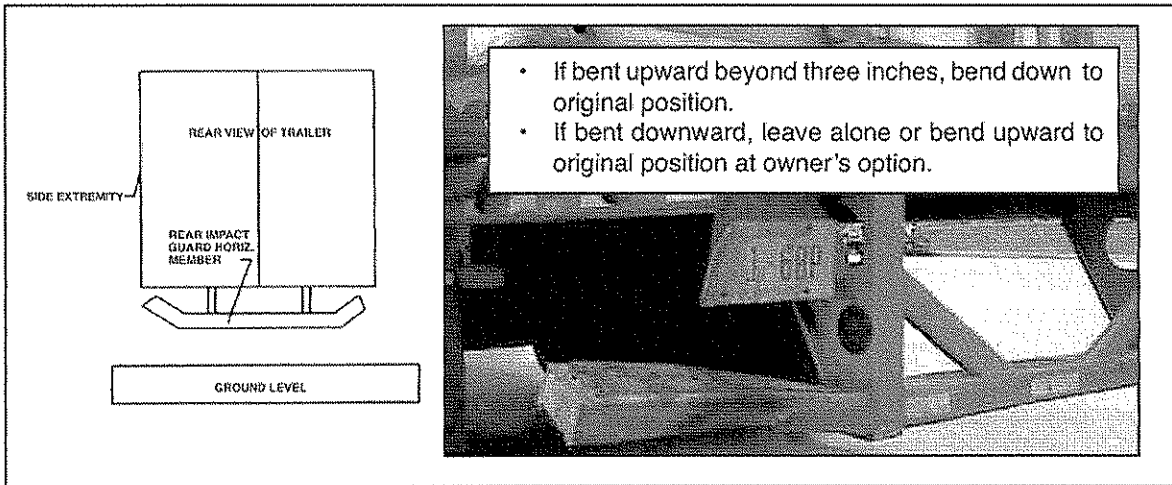
Figure 4

In some instances, the ends of the horizontal member are bent upward or downward (see Figure 4) or towards the front of the trailer (see Figure 5). If it is bent upward, it can be bent down to its original position. If it is bent downward, it can be left alone or bent upward to its original position at the equipment owner's option.

**CAUTION:** Use only cold bending methods. Heating the guard may affect its strength. Also, repetitive bending should be avoided since it will have a detrimental effect on strength.

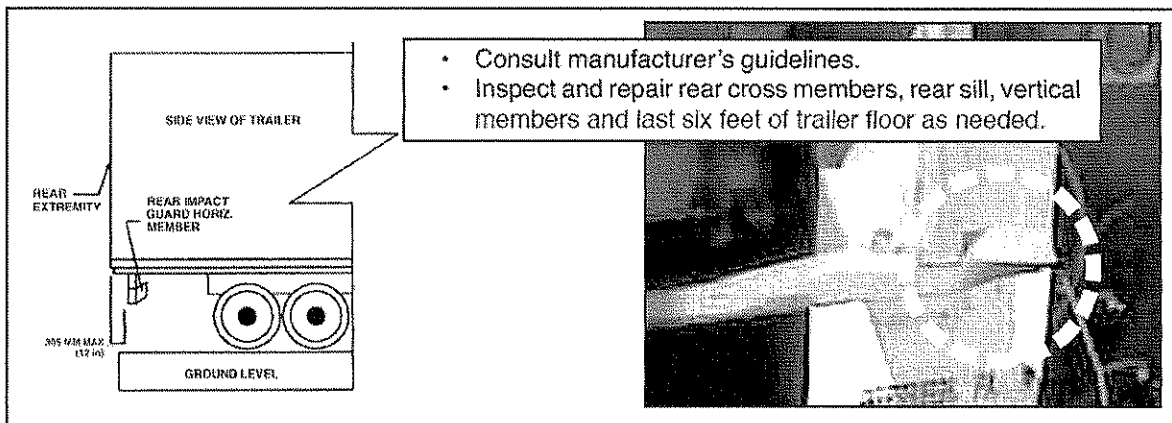
Figure 6

Sometimes the middle of the horizontal member is bent toward the front of the trailer (see **Figure 6**). Consult the manufacturer for repair guidelines for this damage condition. Additionally, in some instances there may be accompanying damage to the cross members at the rear of the trailer. The rear cross members, rear sill, vertical members and last six feet of the floor must also be inspected for damage, and repaired as needed. If replaced under manufacturer's recommendations, the horizontal members should be replaced with an OEM-approved replacement member having the same or better metal alloy and dimensions as the original. Installation must follow manufacturers' instructions.

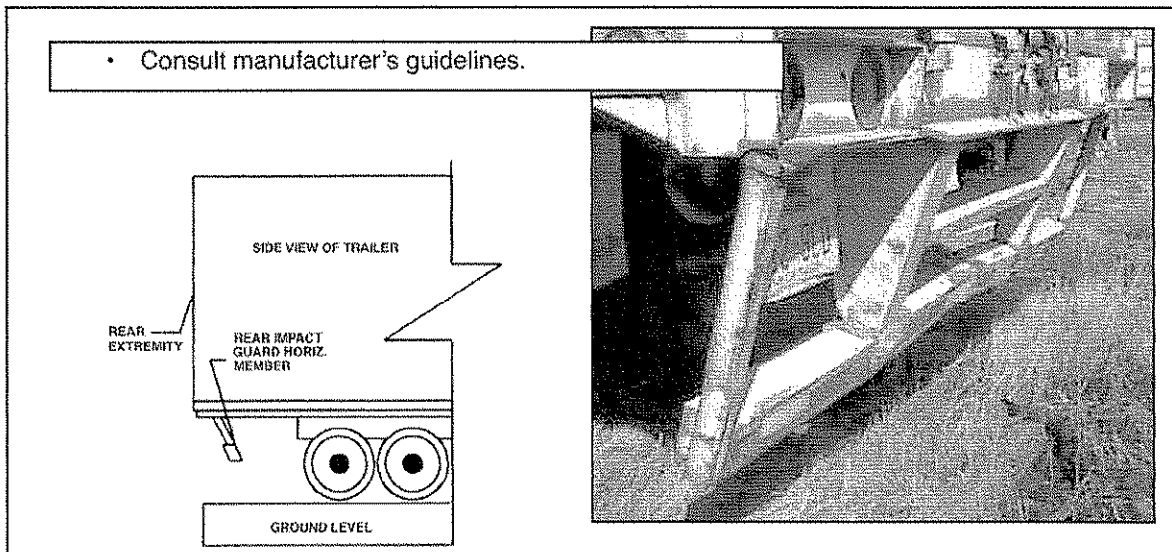
Figure 7

At times, there is no damage to either member, but the entire guard is canted inward to the front of the trailer (See **Figure 7**). In this situation, consult the manufacturer for specific repair guidelines. Also note that the rear cross members, the rear sill, the vertical members and last six feet of the floor must also be inspected for damage, and repaired as needed per manufacturer guidelines.
